STS-27R OV-104 ORBITER TPS DAMAGE REVIEW TEAM

SUMMARY REPORT

VOLUME I

FEBRUARY 1989

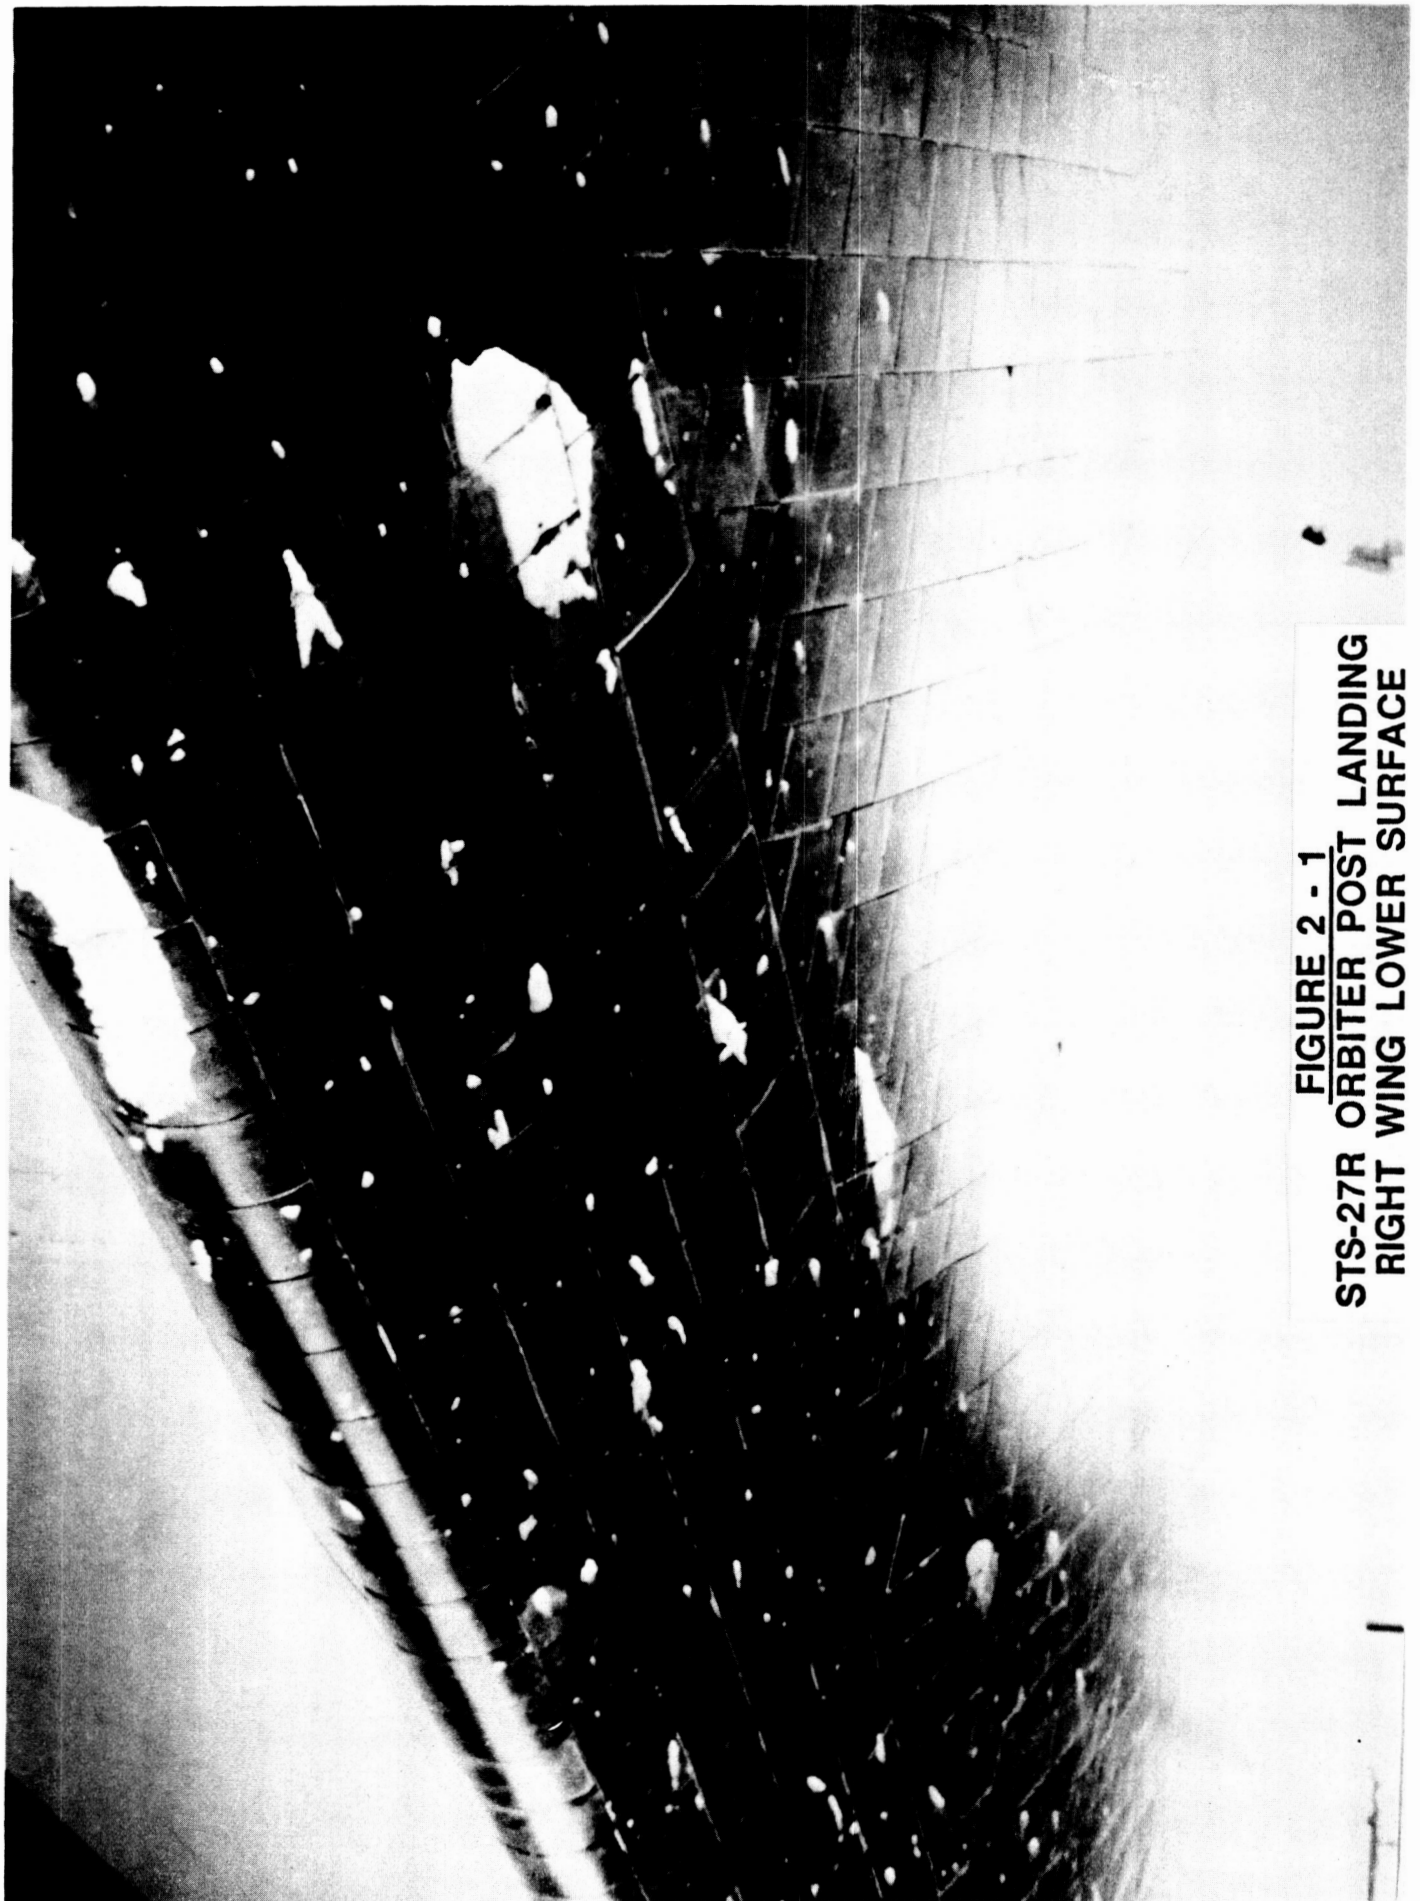
FIGURE 2 - 1
STS-27R ORBITER POST LANDING
RIGHT WING LOWER SURFACE

The Atlantis TPS was inspected at Dryden Flight Research Facility, and also after being ferried back to KSC. While it was at Dryden, the TPS damage was measured, mapped, and recorded. The damage severity and the contrast in right side versus left side damage is readily discernible in Figures 2-1, 2-2, 2-3, and 2-4. The inspection results and damage distribution are as follows:

- a. Total recorded damage sites were 707, with 644 occurring on the lower surface.
- b. Total recorded damage sites with any dimension greater than one inch were 298, with 272 occurring on the lower surface.
- c. The left side had only two damage sites greater than one inch.
- d. The elevon lower surfaces were undamaged.
- e. The right OMS pod had 14 damage sites greater than one inch.
- f. The right rudder speed brake had four damage sites greater than one inch.
